## BEKO TECHNOLOGIES Quick Facts

## Leakage at hemp-sealed fittings

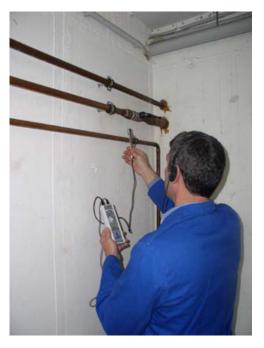
Compressed air leaks are a major cause of energy loss. Leakage occurs around the clock, even at times when no compressed air is consumed and the compressor runs in standby mode.

Hemp-sealed piping systems are particularly prone to leakage, as the hemp paste dries out over time so that more and more compressed air can escape through cracks in the material. The problem is particularly prevalent in applications with very dry air.

Leakage can best be detected by means of ultrasonic leak detectors.

Minor leaks at small fittings can be fixed using modern sealants such as Teflon tape.

Hemp-sealed pipelines should be gradually replaced with modern, gap-free piping systems such as press-fitted, soldered, welded of glued pipelines. Fittings with sealing O-rings are equally suitable and have the added advantage that they can be easily opened when required.
